Tissue Reaction to a 316L Stainless T Plate Fabricated for Pelvic Osteotomy in Dogs

Tissue reaction to a 316L stainless T plate fabricated for pelvic osteotomy was examined radiographically and histologically in 3 experimental mongrel dogs 52 weeks after plate implantation on the non-osteotomized ilium. The adverse effects of long-term plate implantation were assessed clinically and radiographically in 7 dysplastic hips of 5 dogs that had undergone triple pelvic osteotomy 3-5 years earlier. The plates were removed from the experimental dogs for corrosion evaluation 52 weeks after the implantation. Serial radiographs of the experimental dogs at 1, 4, 8, 12, 24 and 52 weeks and of the hip dysplastic dogs at 3 to 5 years showed no plate corrosion in the tissue surrounding the plates and no perceptible changes to indicate aggressive bone lesion. Gross examination of the tissue adjacent to the removed plates in the experimental dogs found no discoloration or trace of stainless steel debris. Histologically, the tissue surrounding the plate was composed of fibrous and adipose tissues. Infection, traces of the metallic debris and foreign-body granuloma formation in response to the presenc

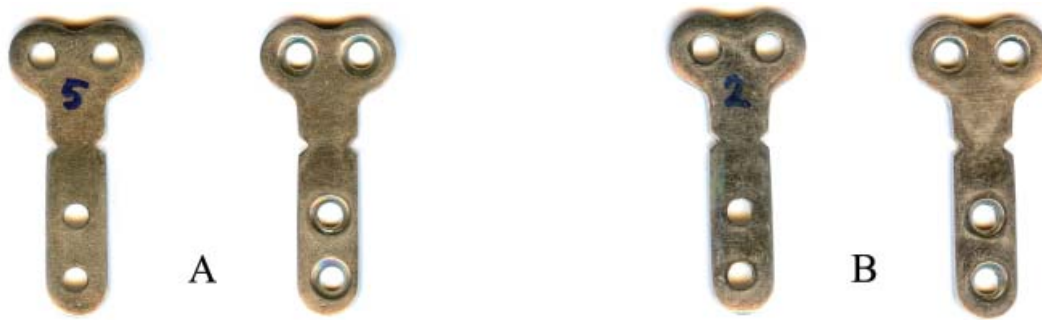
Figure 2 Both surfaces of the 316L stainless T plates fabricated for triple pelvic osteotomy; A: used plates, B: unused plates of the same production batch.

To increase versatility and to reduce the cost of the implant, the authors have fabricated a T plate modified from the Synthes and the Marquardp TPO plates (Figure 2). This 3.5-mm plate has only one size and one configuration that is applicable to all sizes of the dog and for either side of the ilium. Similar to the Marquardp plate, the T plate must be twisted at the shaft dent to the angle required for each case. Like pins, screws and other orthopedic implants including the Slocum, the Synthes

Fabricated T plates: The fabricated 3.5-mm T plate (Figure 2) has the configuration modified from that of Synthes and Marquardp TPO plates. The plate is made of 316L stainless steel which is the standard material used for the manufacture of medical implants including the Slocum, the Synthes and the Marquardp TPO plates. One of the 2 axes of the plate shaft is elongated in shape and dented in a way similar to that of the Synthes TPO plate. The other axis is perpendicular to the first one and has a shape resembling that of the Marquardp TPO plate.

Macroscopically, the upper sides and the under sides of the retrieved plates appeared smooth and were not corroded. There was no perceptible difference in surface appearance between the plates retrieved from the experimental dogs 52 weeks after the implantation and the unused plates from the same production batch. All retrieved plates maintained their metallic luster and color. There was no rust brown staining, nor crevices or a rough finish on the plate surfaces to indicate surface corrosion. Microscopically, the surface characteristics of the retrieved plates were not notably different from those of

the unused plates from the same production batch. Comparable scratches and pits were observed on the surfaces of both the used and the unused plates. These findings suggest that no corrosion occurred (Figure 2).
