The use of color modifier and resin cement to mask tetracycline-stained teeth restored with porcelain veneer: a case report

(CU Dent J. 2012;35:119-30)

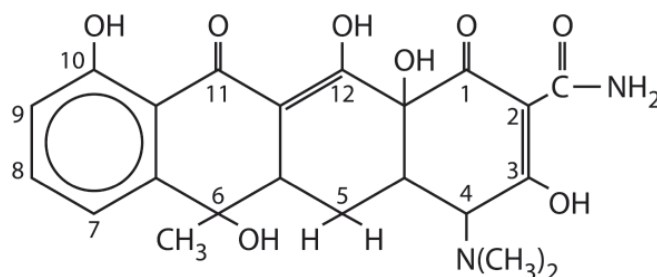
Figure 1 Chemical structure of tetracycline.

In 1948, tetracycline broad-spectrum antibiotics were introduced for use in treating gram-positive and gram-negative bacteria in children and adults.¹ All tetracycline compounds consist of four fused cyclic rings (Figure 1). While effective in the treatment of infection, tetracyclines also have systemic side effects—for example, pregnant women are particularly susceptible to tetracycline-induced hepatic damage.² Tetracyclines also cross the placenta and have toxic effects on the developing fetus; therefore, they are contraindicated for use during pregnancy.¹ Tetracycline antibiotics are often used in the treatment of acne in adolescents and young adults. Long-term use of tetracycline, particularly minocycline (Minocin) which is a semi-synthetic tetracycline derivative. One of the most obvious and well-documented side effects of tetracycline use is its incorporation as a fluorescent pigment into mineralized tissues, which are being developed at the time of administration. Tetracycline has the ability to chelate calcium ions and incorporate themselves into teeth, cartilage and bone, forming a tetracycline-calcium orthophosphate complex³ resulting in discoloration and enamel hypoplasia of both the primary and permanent dentitions.⁴ Therefore, tetracycline should not be used by children whose teeth are still developing.

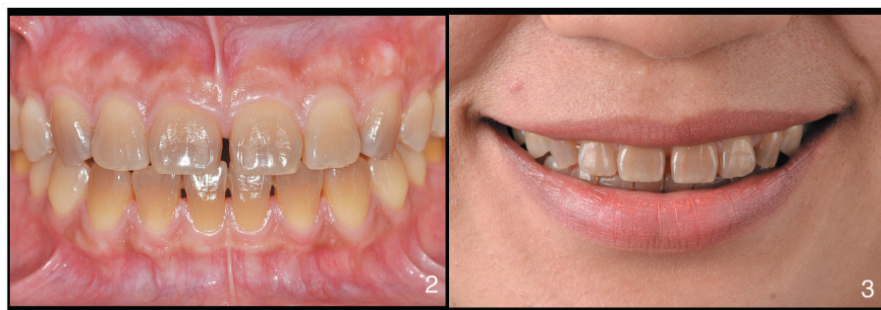
Figure 2 A 36-year-old Thai female patient presented with concerns about tetracycline-stained teeth and space between teeth 11 and 12.

Figure 3 Facial view of the patient's smile showed a low smile line

and space between teeth #11 and #21 of 1 mm (Figure 2). The dark brown discoloration was pronounced in the middle third and incisal third of all teeth and, to a lesser degree, in the cervical third. The patient had a low smile line (Figure 3) and a Class 1 molar relationship. Her oral hygiene was good, and the gingival tissue was in healthy condition. The patient had rejected whitening prior to treatment. She desired

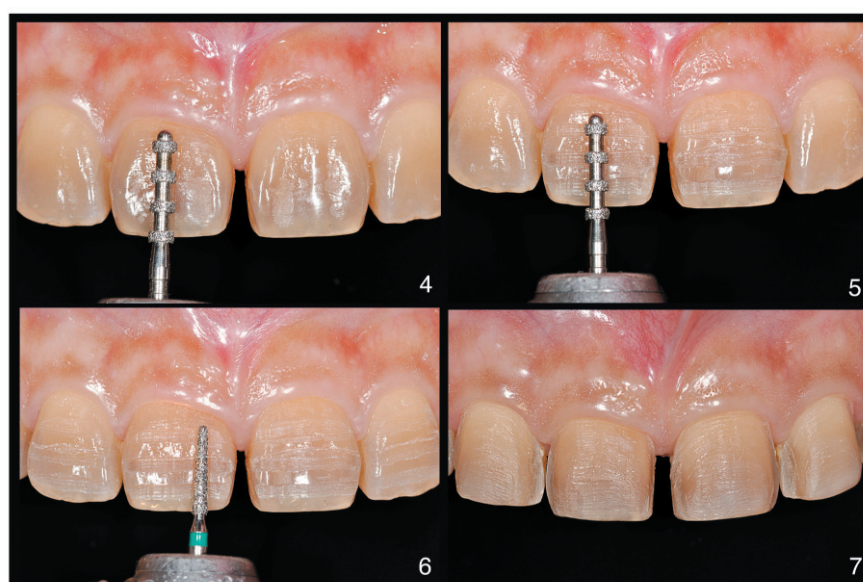
Figure 4 The LVS diamond bur was placed on the labial surface of the tooth.

Figure 5 The tooth surface after depth cut.

Figure 6 The round-ended diamond bur was used in three different planes.

Figure 7 View after the preparation was finished.

After the treatment plan was accepted by the patient, teeth were prepared for porcelain laminate veneers. For the maxillary teeth, a depth-cutting diamond-coated bur (Komet® LVS-2; Brasseler, Lemgo, Germany) was used to create cuts of approximately 0.3 mm deep in three planes: the incisal third, middle third and cervical third. Then, round-end cylinder diamonds (D8 and D16 Intensiv®; Swiss Dental Products, Grancia, Switzerland) were used to remove the labial enamel of the prepared tooth to the level of the depth created by the depth-cutting bur. The proximal contacts were cut in half, and the remaining half was maintained in order to preserve tooth width, shape and contour. The mesial surfaces of both central incisors were prepared through the lingual surface (Figures 4-7). The gingival margin was prepared for a chamfer-type margin approximately 0.5 mm below the gingiva. The incisal edges were reduced by 1.0 mm to create sufficient room for layering the veneers to achieve translucency. After preparation, an Ultrapak® retraction cord #3 (Ultradent

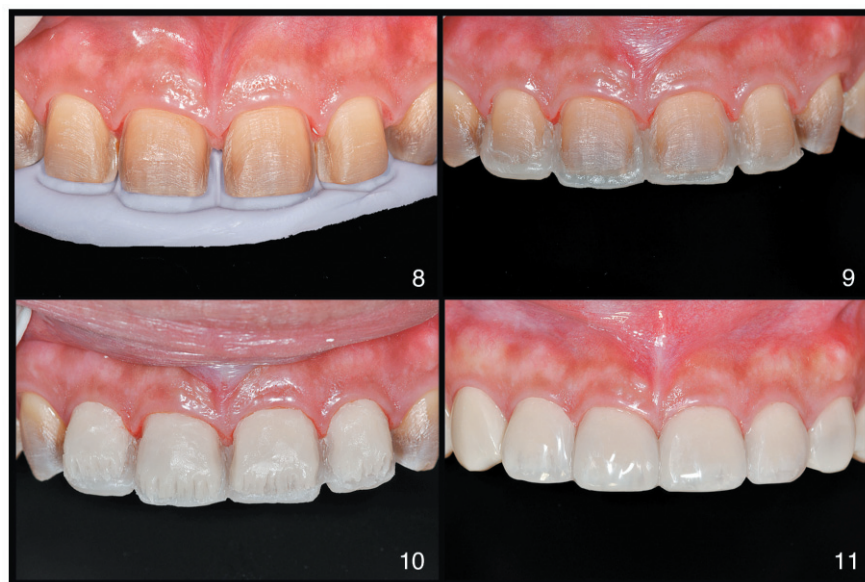
Figure 8 The silicone index was placed on the palatal surface of the prepared teeth.

Figures 9 and 10 The resin composite was placed, and freehand layering technique was used to create the temporary veneers.

Figure 11 After polishing of the temporary veneers.

A silicone index made from the diagnostic wax-up model was placed at the palatal surfaces of the upper teeth (Figure 8). Light-cured flowable resin composite (A2 Premise®; Kerr) was placed at the interproximal and incisal area to create the matrix for resin composite temporization. In this case, bonding agent was not needed because the temporary was highly retained to the tooth from the interproximal resin composite. Resin composite was applied by free-hand

carving and shaping to create a natural tooth shape. The patient was instructed to brush every day without using dental floss for one-week period of temporization (Figures 9–11).

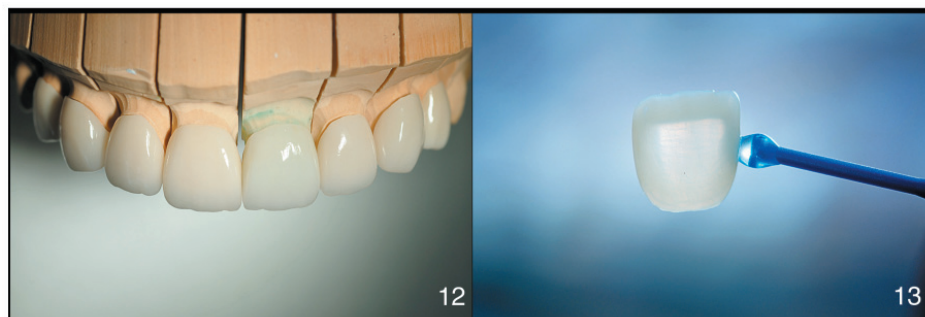
Figure 12 View of the definitive porcelain veneer restoration on the working model.

Figure 13 The porcelain veneer had visible translucence.

A stone model was poured and working dies were fabricated. The model was waxed-up into the final tooth shape and proportionally corrected. Photographs taken before and after preparation were used as a communication tool with the laboratory technician. The patient accepted A1 color tabs (Vita classic® shade; VITA Zahnfabrik, Bad Säckingen, Germany) as the final shade. In order to minimize the effect of the underlying color, a medium opacity (MO) IPS Empress E. max ingot (IvoclarVivadent, Liechtenstein) was used to fabricate the ceramic veneer (Figures 12–13). However, the veneers were so thin (0.5 mm) that they would not be able to mask the moderate to severe tetracycline staining of the tooth; therefore, additional color modifier or opaquer was used as part of the initial plan.

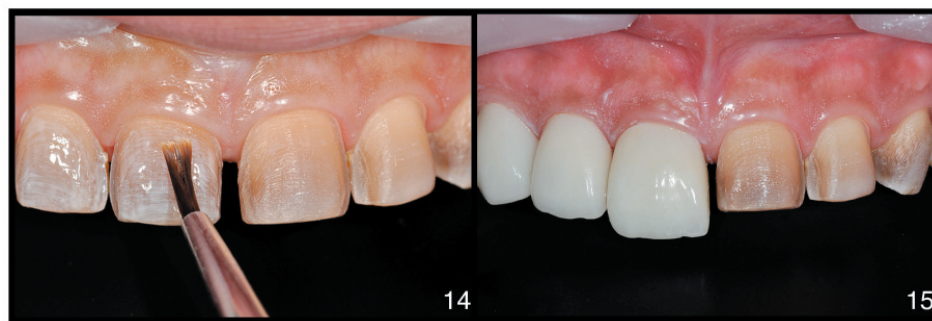
Figure 14 A thin layer of A1 opaque (Kolor + Plus®; Kerr) was applied on the tooth surface after applying the bonding agent.

Figure 15 The porcelain veneers were cemented on teeth #11, #12 and #13.

On the prepared teeth, enamel was cleaned using a flour of pumice slurry, washed with water, and air-dried. A waterproof elastic plumbing tape was then placed on the adjacent teeth. As planned, three veneers were placed on half of the arch and finished before placing the veneers on the opposite half. Teeth numbers 11, 12 and 13 were etched with 37% phosphoric acid for 15 s; then the dentin adhesive (Optibond Solo Plus®; Kerr) was applied thinly for 15 s using light brushing motion over the surfaces and air thin for 3 s. A thin 2–3 layers of opaquer (A1 opaque, Kolor + Plus®; Kerr) was applied over the bond surface with a fine brush to create a thin layer of opaquer which would help to mask the dark tetracycline staining of the teeth. The opaquer must be kept thin so it would not interfere with the fit of veneer (Figure 14).

The inner surfaces of three veneers (11, 12, 13) were coated with resin luting cement (shade +1, Variolink Veneer®, Ivoclar Vivadent, Liechtenstein) and were carefully seated into position. After the removal of excess cement interproximally and gingivally, the resin luting cement was pre-cured using a 5 s application of curing light (Optilux®, Kerr) while the veneers were stabilized by finger pressure. The excess polymerized luting cement was removed carefully using a surgical blade no. 12 before finally light-curing with 40 s of light both labially and palatally (Figure 15).

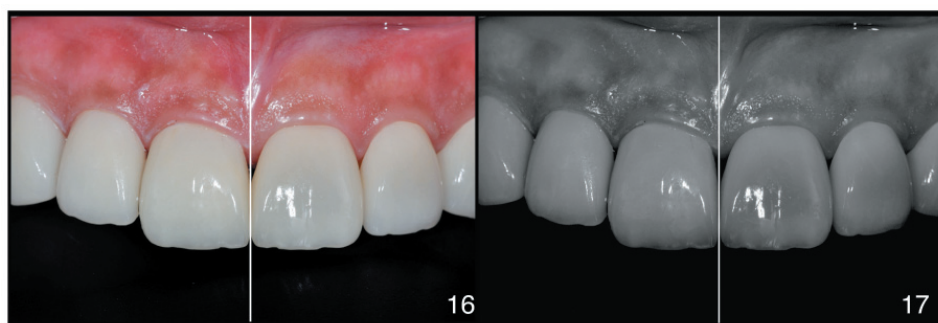
Figure 16 and 17 After cementation with Kolor + Plus® on teeth #11, #12 and #13, compared to the unmasked and uncemented veneers contralateral anterior teeth.

After cementing #11, #12 and #13, the veneers of #21, #22 and #23 were tried on the teeth with water. These demonstrated the appearance of veneers without the use of color opaquer or resin cement. As shown in Figures 16 and 17, the opaquer was able to effectively mask the dark color underneath the porcelain veneers. After fine finishing of the mesial of veneered tooth #11, the veneers (21, 22, 23) were tried on. Then they were cemented using the same protocol described previously. Finally, veneers of #14 and #24 were placed on the teeth in the same manner. After

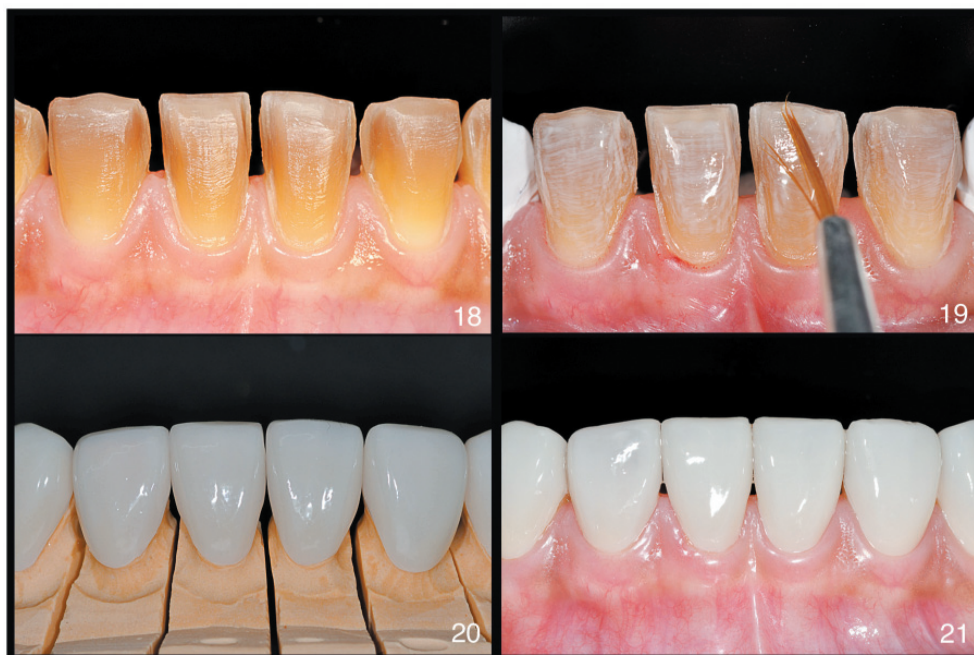
Figure 18 The lower anterior teeth after preparation.

Figure 19 Following the bonding agent, Kolor + Plus® was applied on the tooth surface.

Figure 20 The porcelain veneers were fabricated.

Figure 21 After cementation with resin cement.

In the mandibular teeth, tetracycline staining was severe in the middle third of the teeth. The same principles of preparation design and procedures used for the maxillary teeth were applied to the mandibular teeth (Figures 18–21).

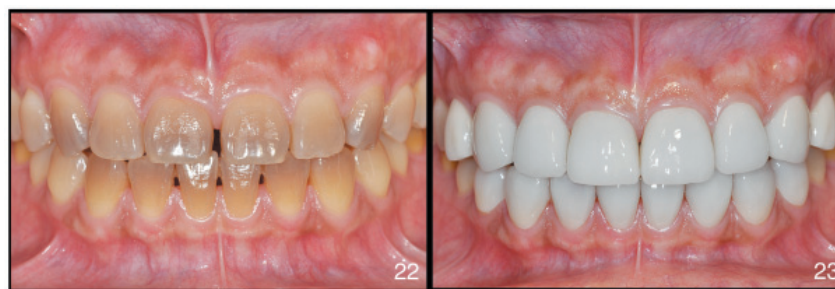
Figure 22 Pre-operative frontal view.

Figure 23 Post-operative frontal view.

Following cementing of the porcelain veneers, the occlusion was verified and adjusted, and veneers were then polished with a porcelain polishing kit (Figure 23). The final results showed that opaque masking technique had the possibility to mask teeth with moderate to severely of tetracycline-stained.
